**White Road Early Learning Center,
7420 Veyaness Road, Central Saanich**

**Construction Impact Assessment &
Tree Preservation Plan**

DATE OF ISSUANCE: March 03, 2021

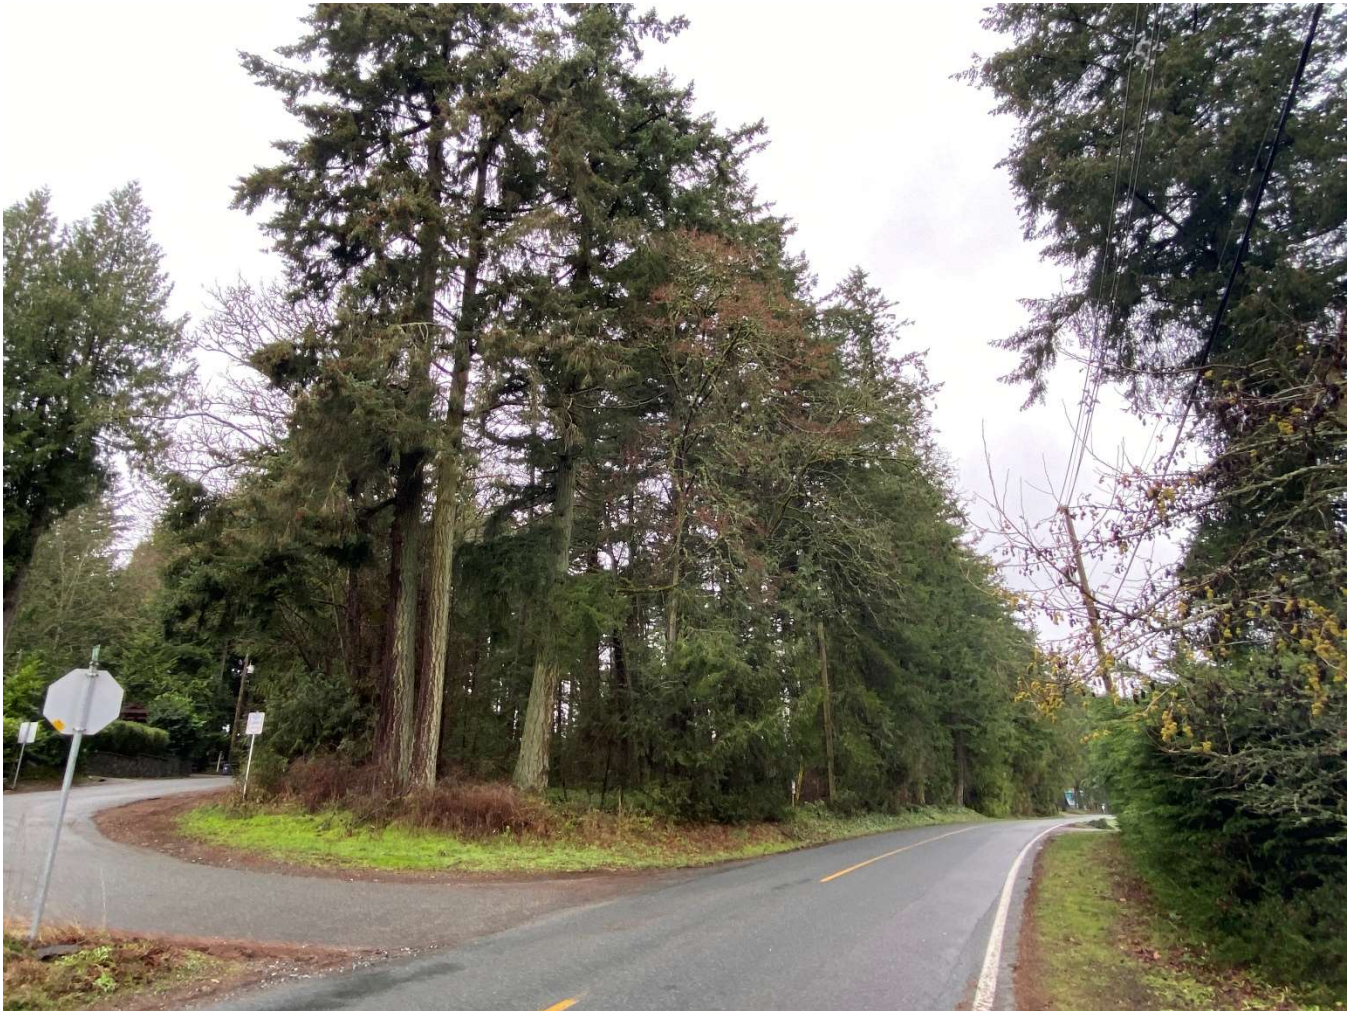
Photograph 1. Looking toward the site at the Veyaness Road and White Road intersection.

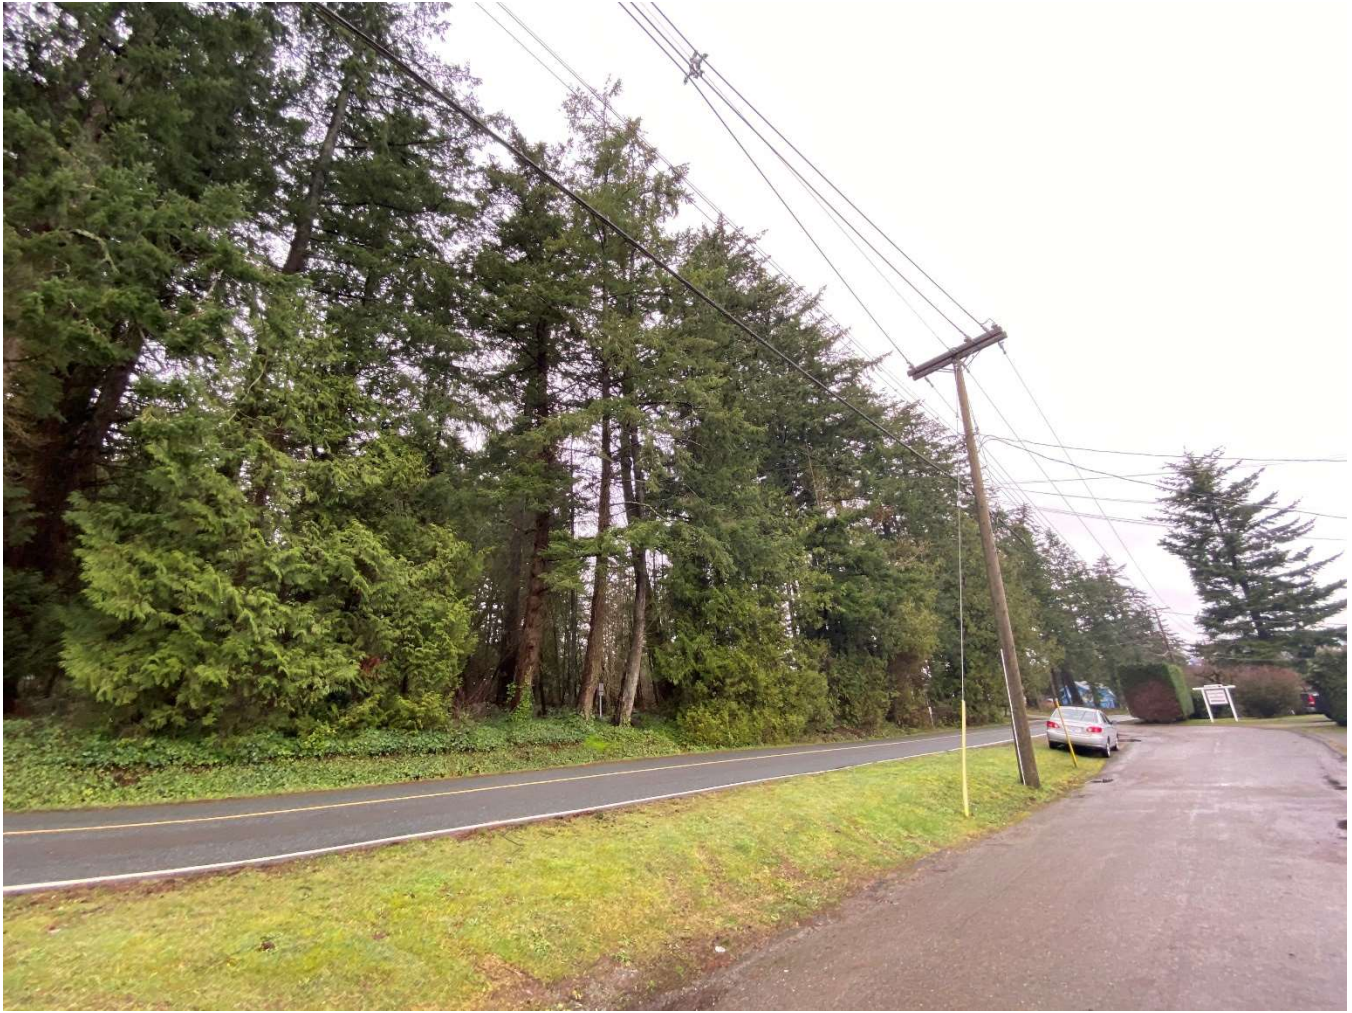
Photograph 2 – Looking toward the Veyaness Road frontage.

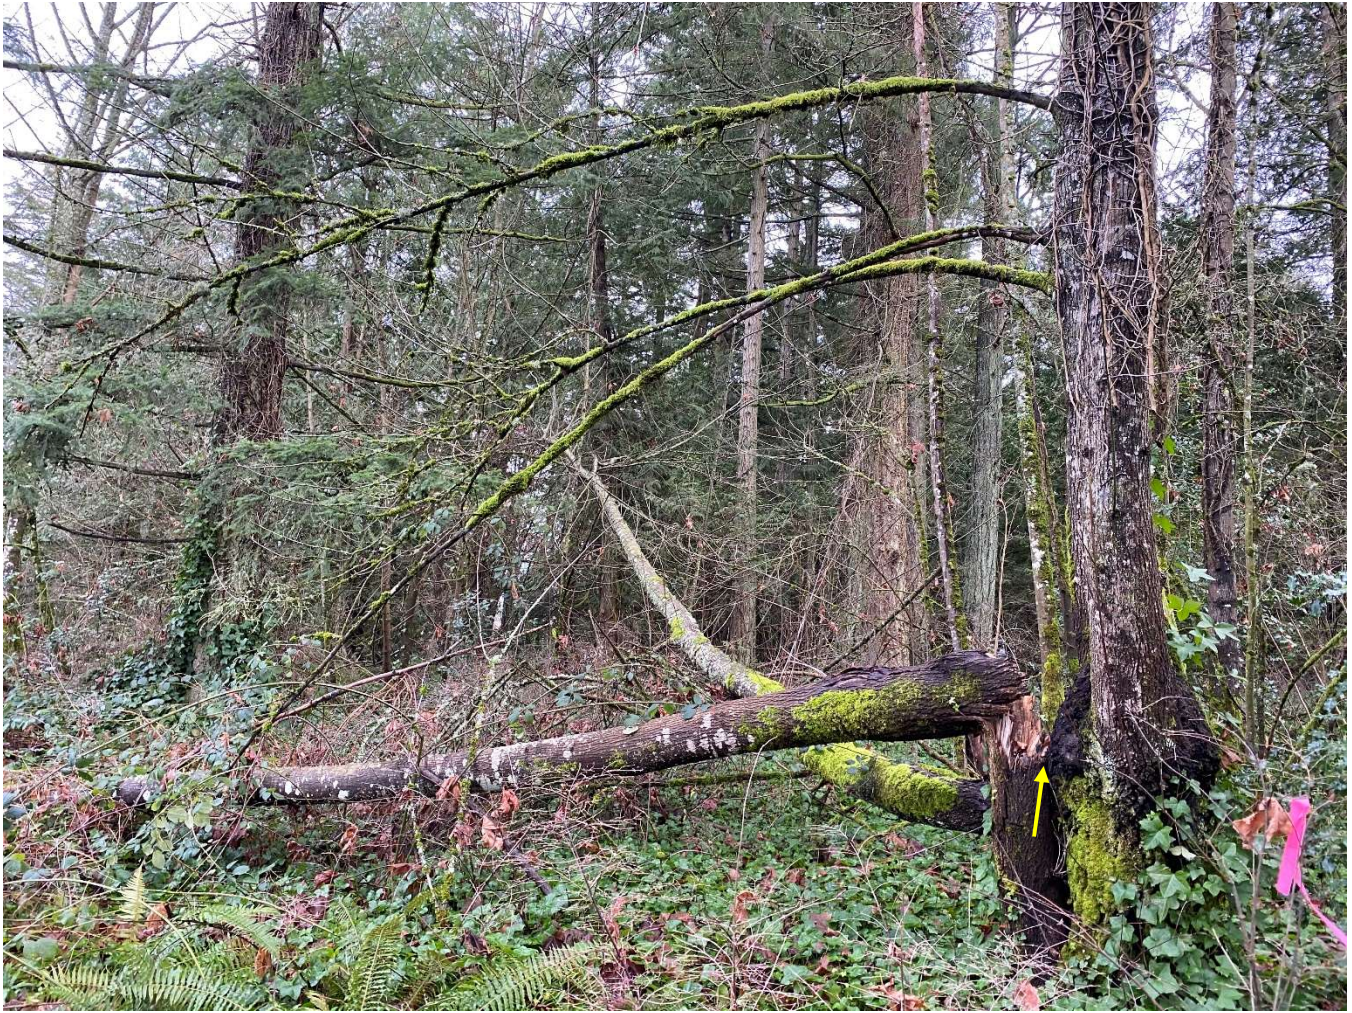
Photograph 3 – Yellow arrow indicates failed portion of Bigleaf maple (tag# 975).

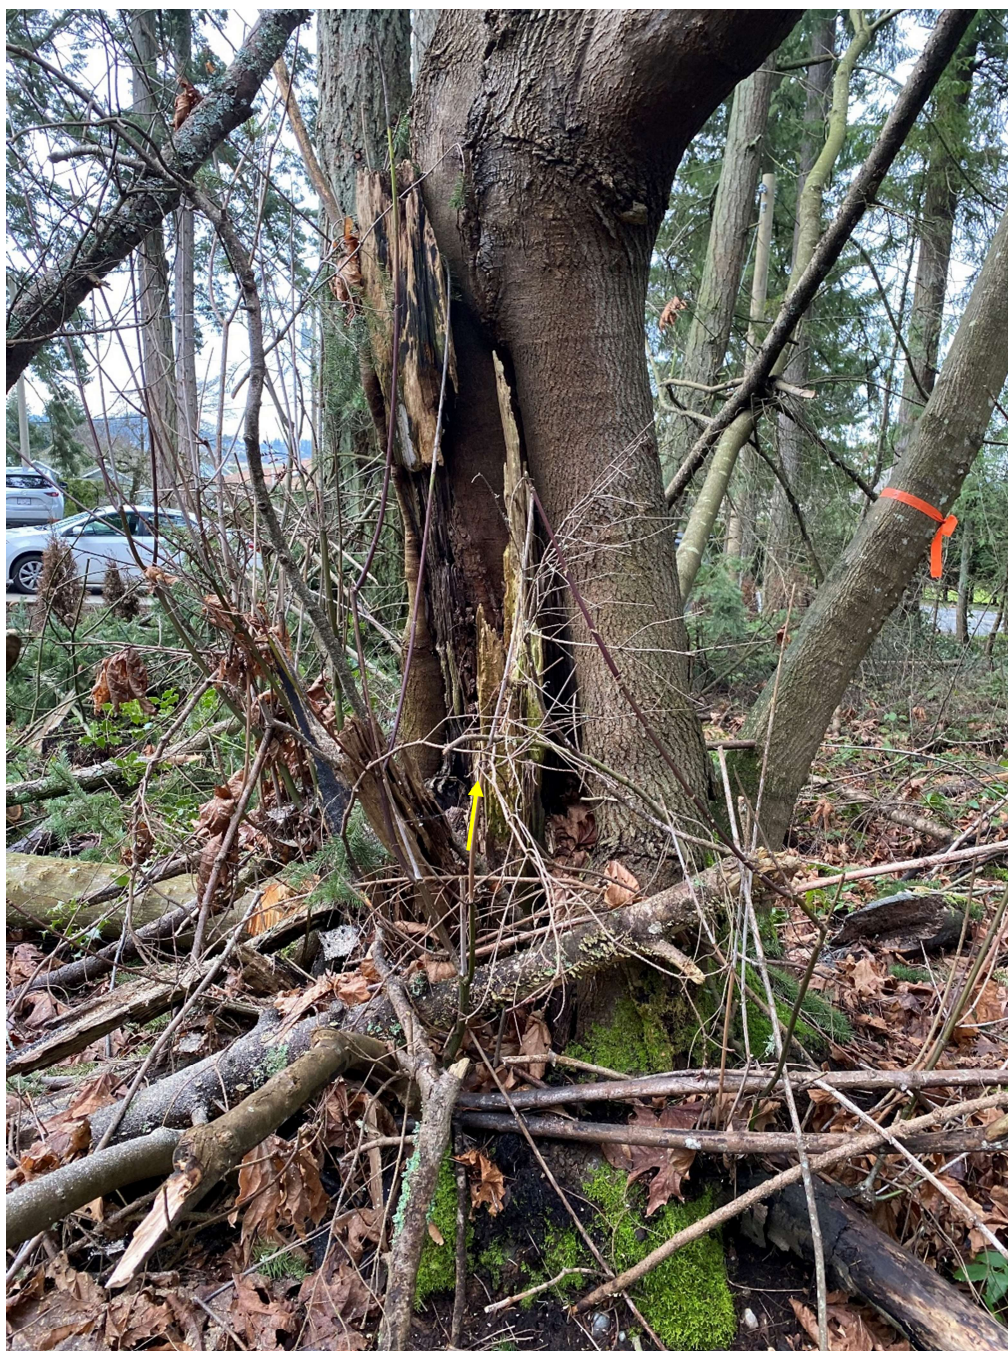
Photograph 4 – Yellow arrow indicates decayed lower trunk of Bigleaf maple (tag# 1000).

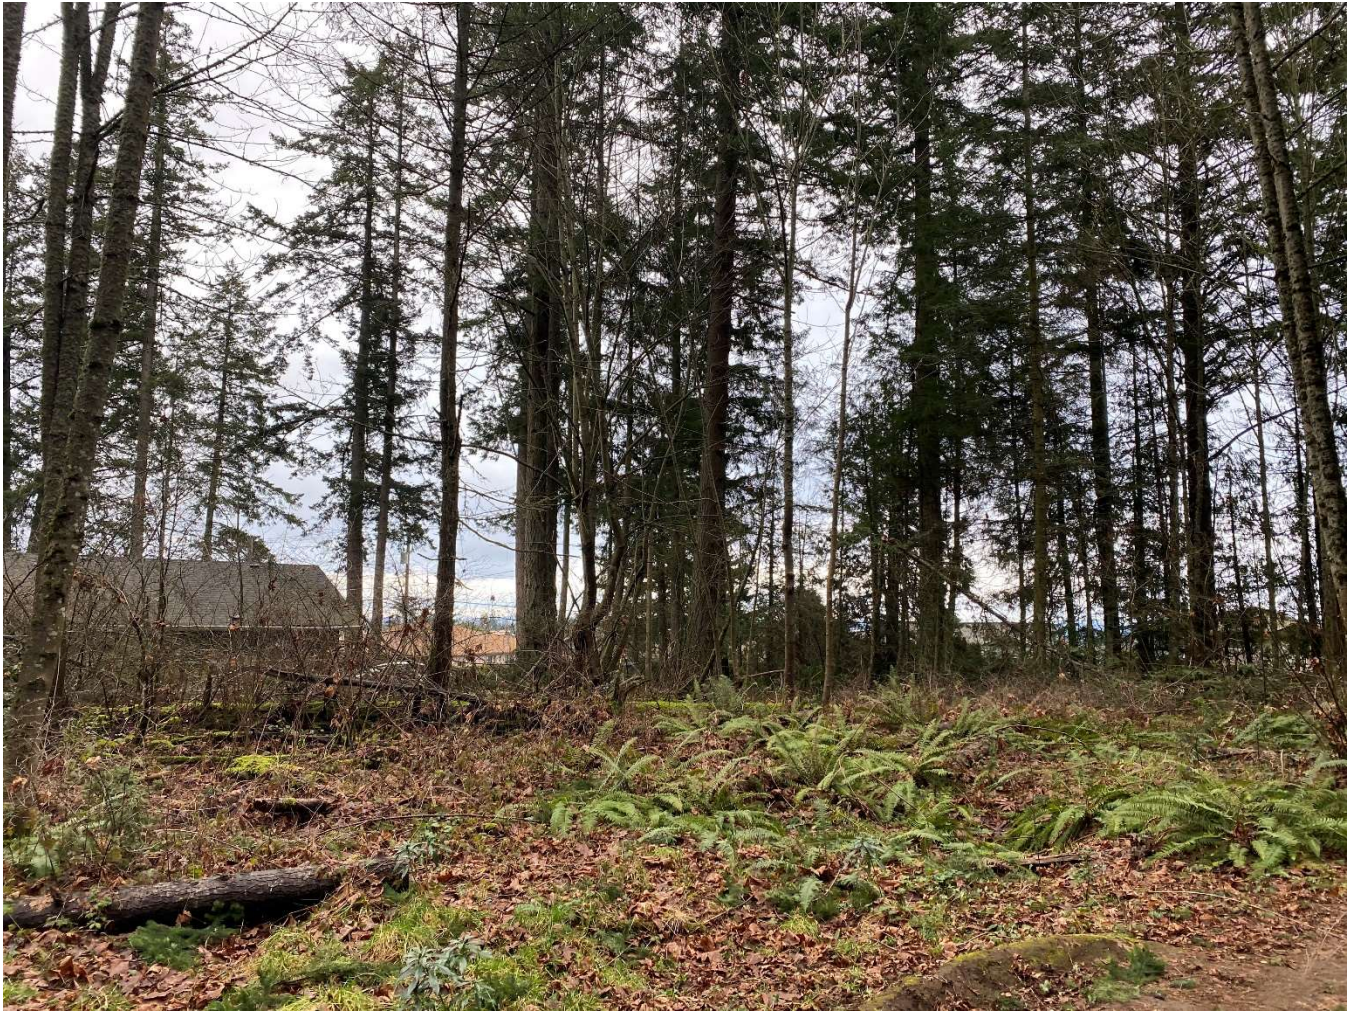
Photograph 5 – Photo taken from the center of the site looking North.

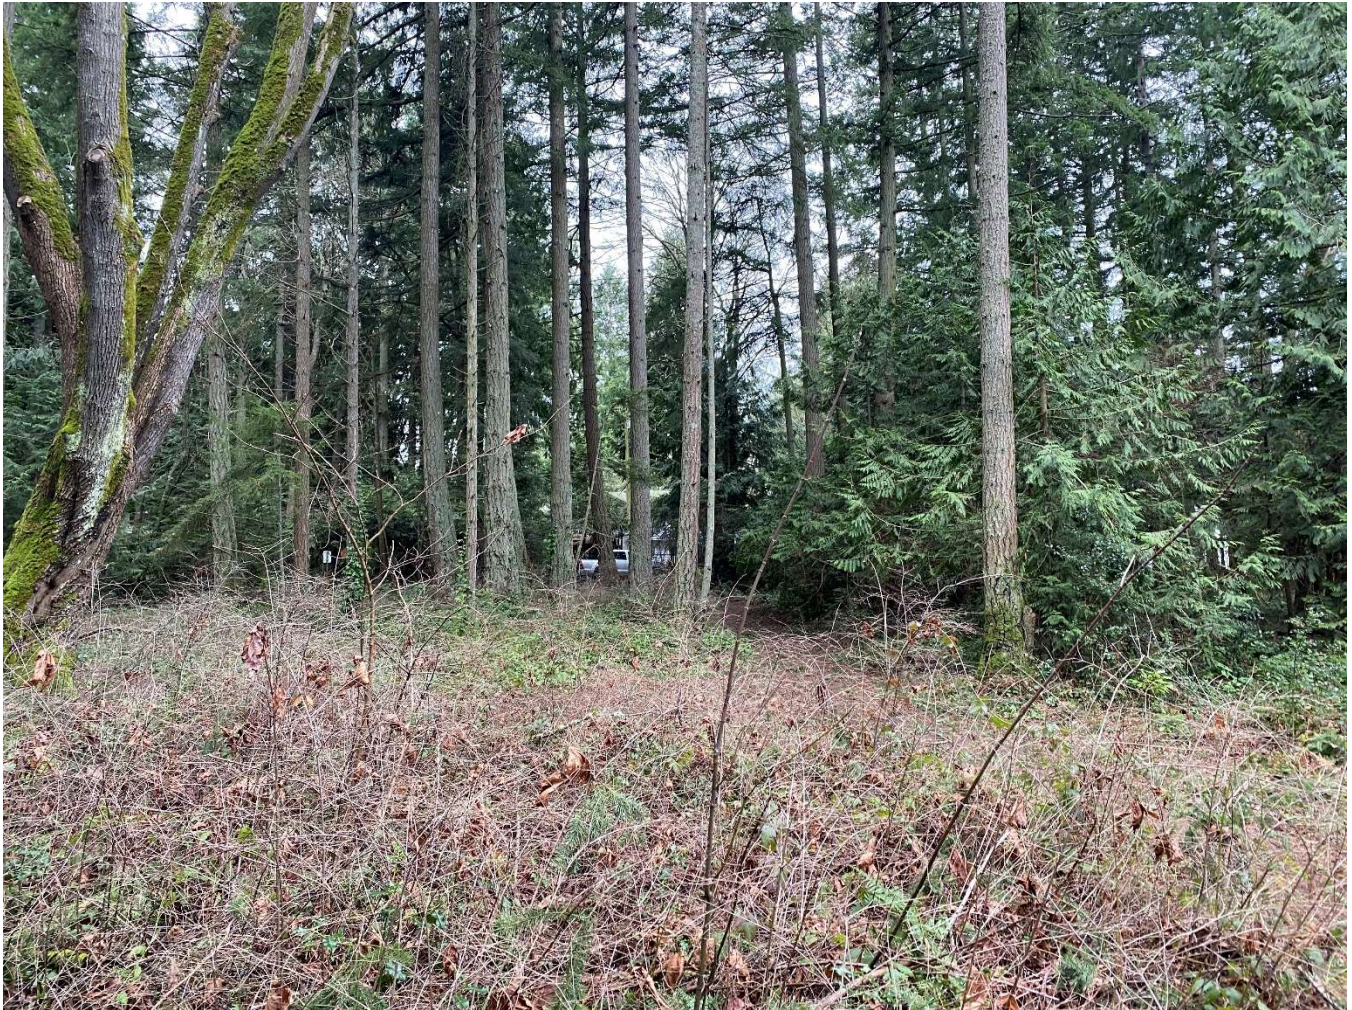
Photograph 6 – Photo taken from the center of the site looking South.
