Nicole da Silva, RPBio & Carter Case, B.I.T. Corvidae Environmental Consulting Inc 6526 Water Street Sooke, BC V9Z 0X1 Andrea Pickard, Environment and Parks District of Central Saanich 1903 Mount Newton Cross Road Saanichton, BC, V8M 2A9

### Re: Letter of Assessment for proposed retaining wall and pool at 8012 Turgoose Terrace

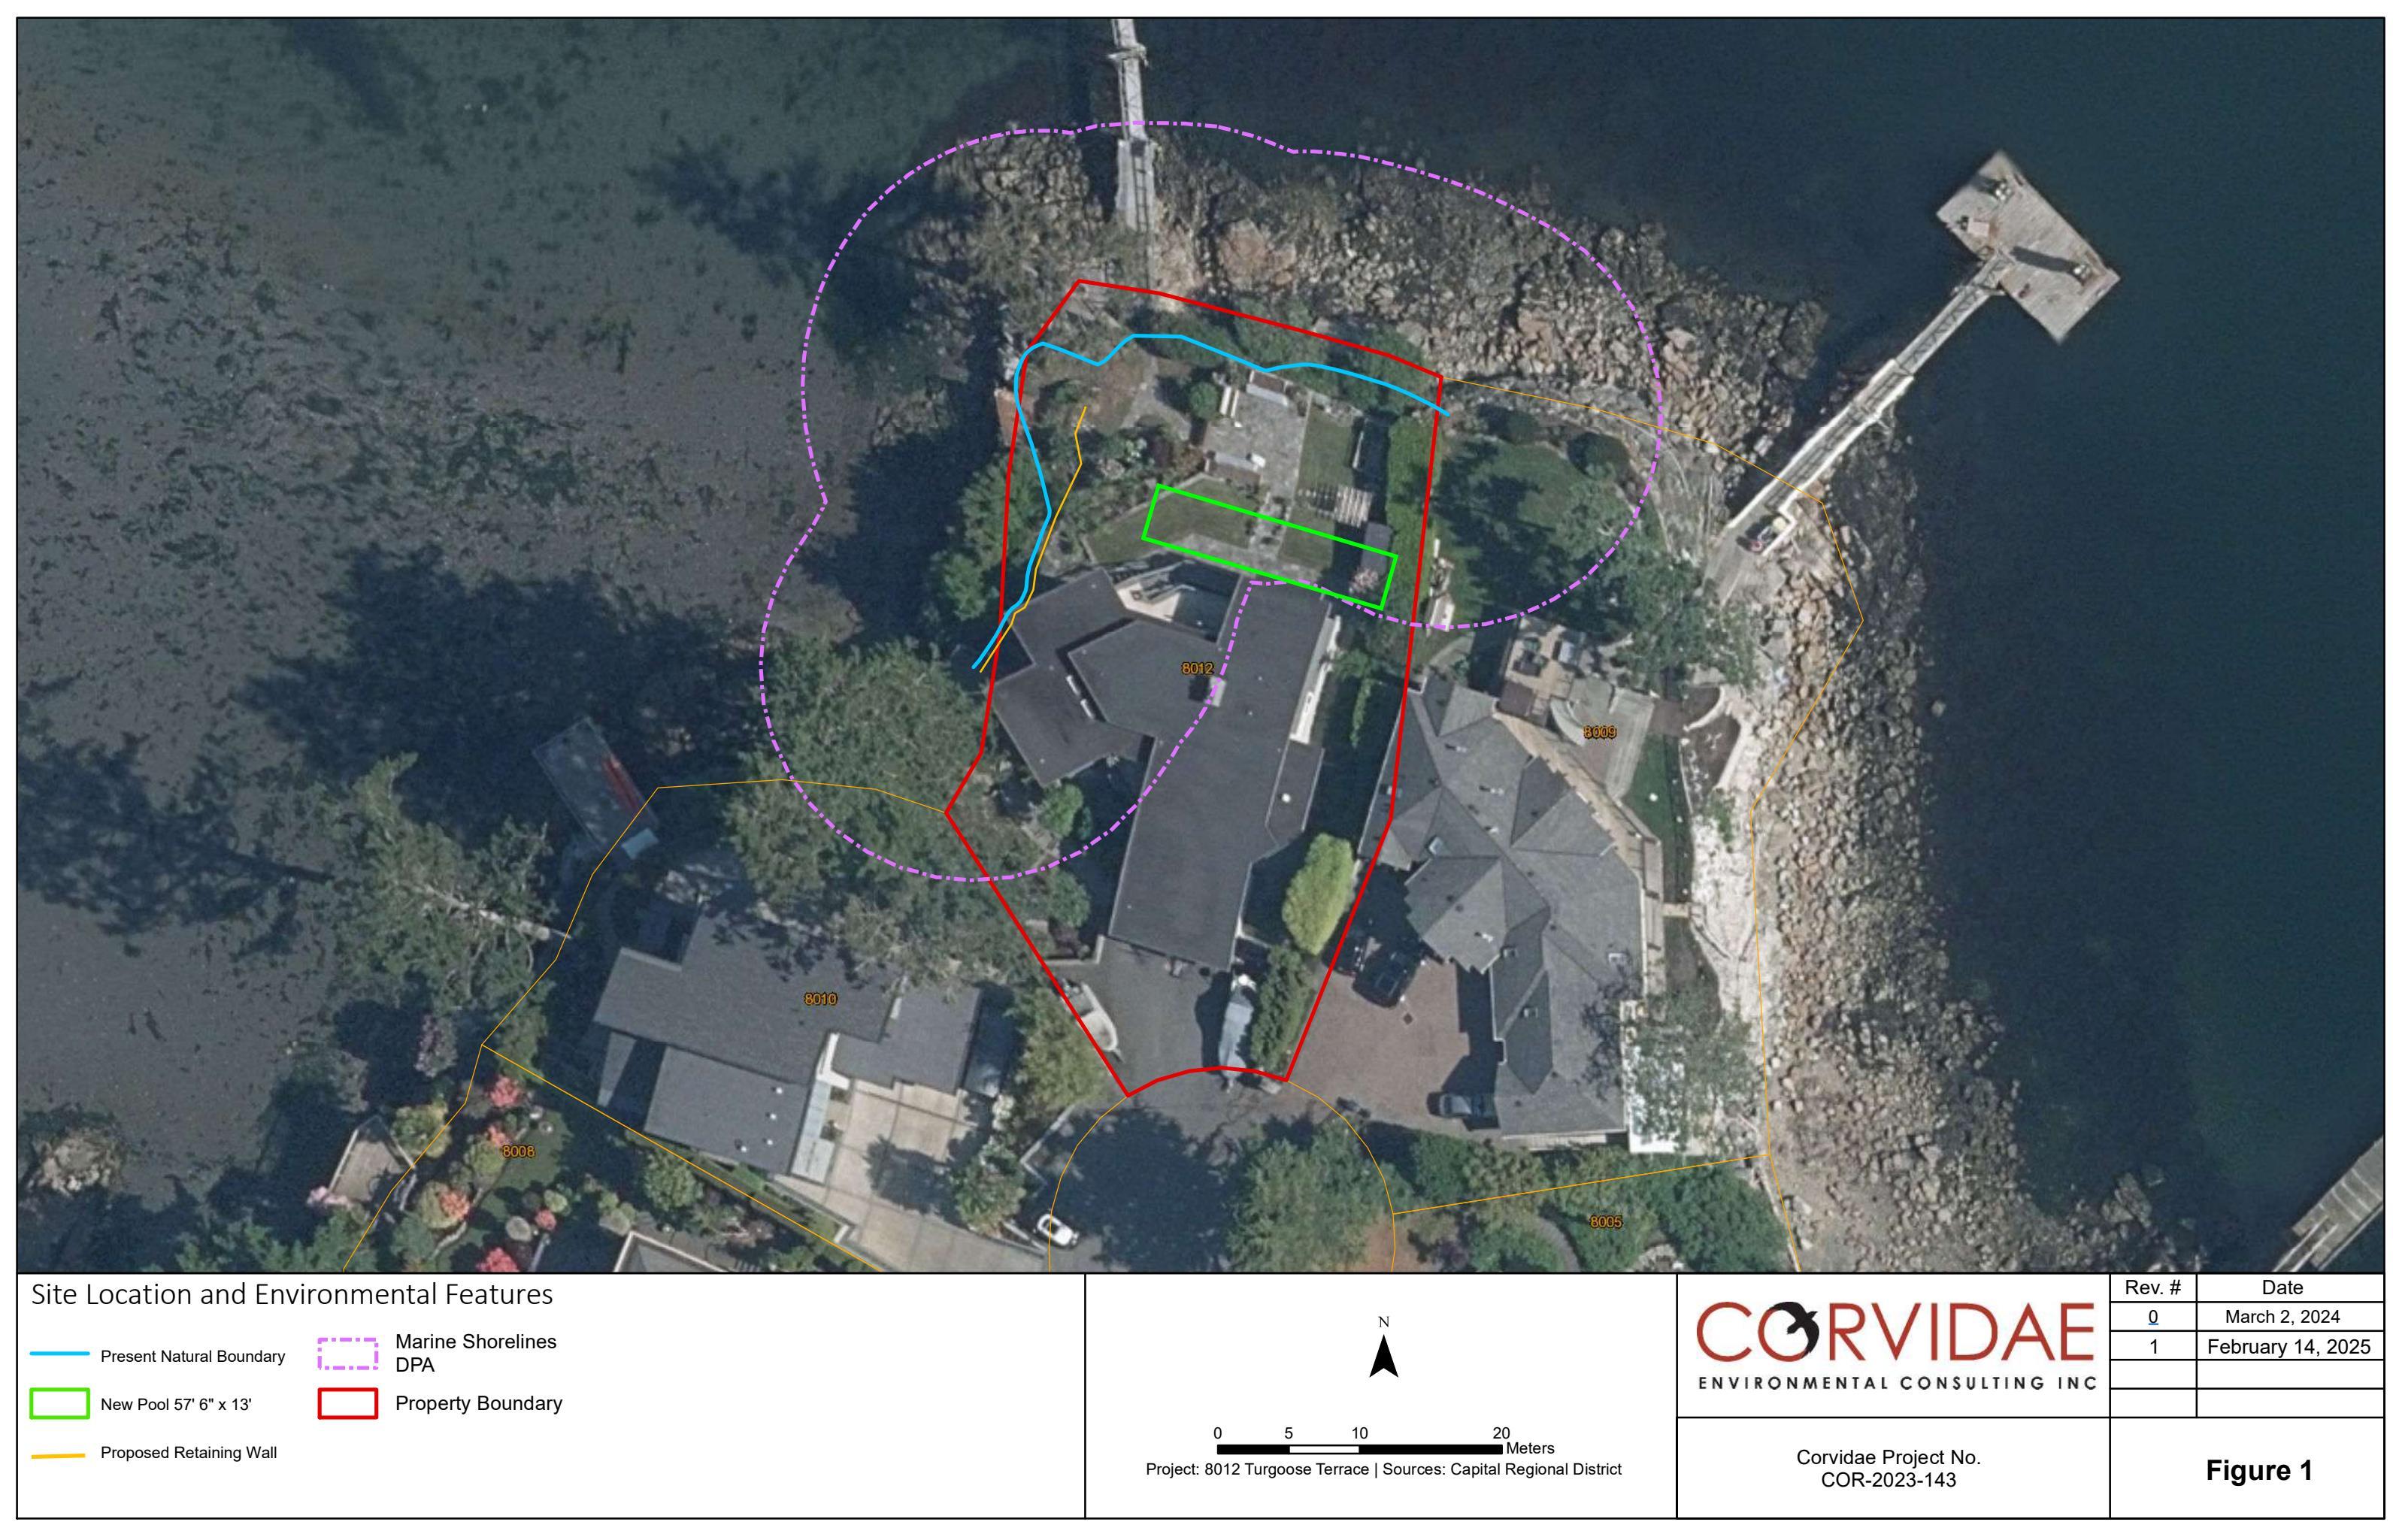
The proposed backyard pool will run east to west directly to the north of the current single-family home (Figure 1). The pool will be approximately 17.5 m in length and 4 m in width. Construction will require the removal of a stone wall and stairs. The installation of the pool will require blasting due to the prevalence of bedrock within the construction footprint.

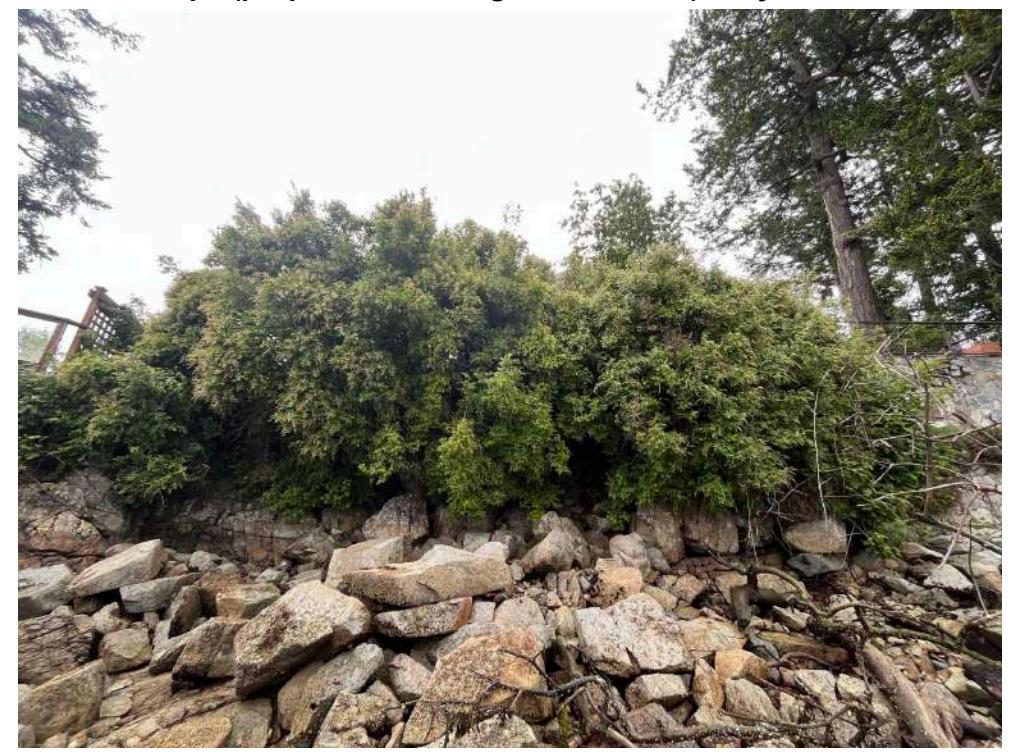
Photo 1. View east of slope (proposed retaining wall location). May 24, 2024.

Where the retaining wall is proposed, the shoreline is characterized by exposed bedrock. The upper sections of the slope are vegetated and have eroding soils. Vegetation on the slope consists of native shrubs (i.e., oceanspray, dull Oregon-grape, snowberry, and salal) mixed with invasive species (i.e., Himalayan blackberry, periwinkle, spurge-laurel). One tree, a young Garry oak, grows at the top of the slope. Where the pool is proposed, the area is highly landscaped and disturbed.
